# **Safety Study of Double-Decker Motorcoaches with Rear Luggage Compartment**

## **Final Report**

U.S. Department of Transportation  
**Federal Motor Carrier Safety Administration**

**January 2018**

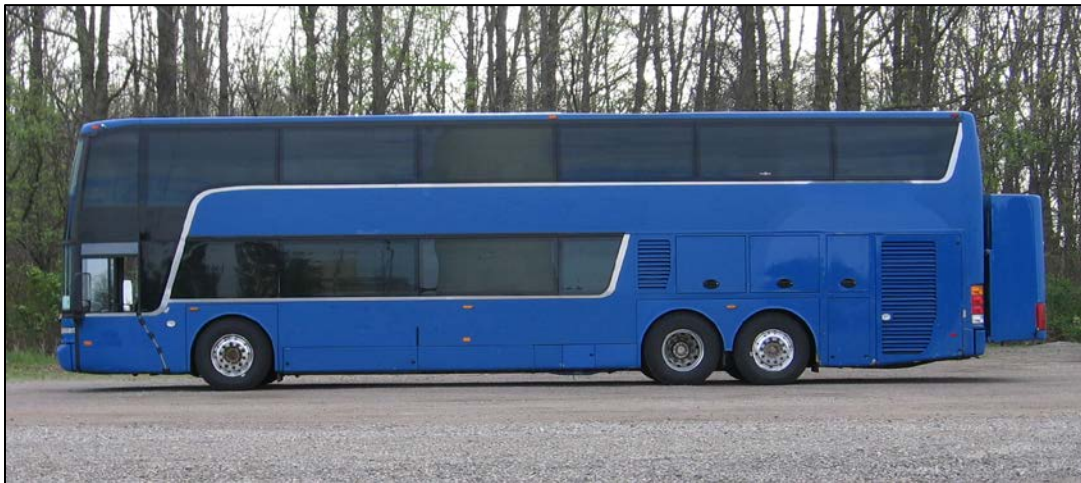
**Figure 1. Photo. The subject vehicle for this study was a 2008 model Van Hool TD925 double-decker motorcoach with a rear luggage compartment.**

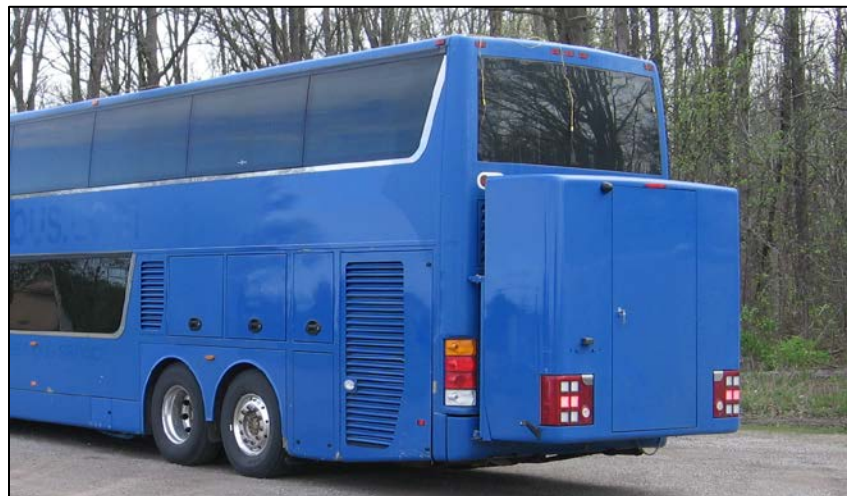
**Figure 2. Photo. The rear luggage compartment extends the length of the motorcoach by about 2 ft, 11 in.**

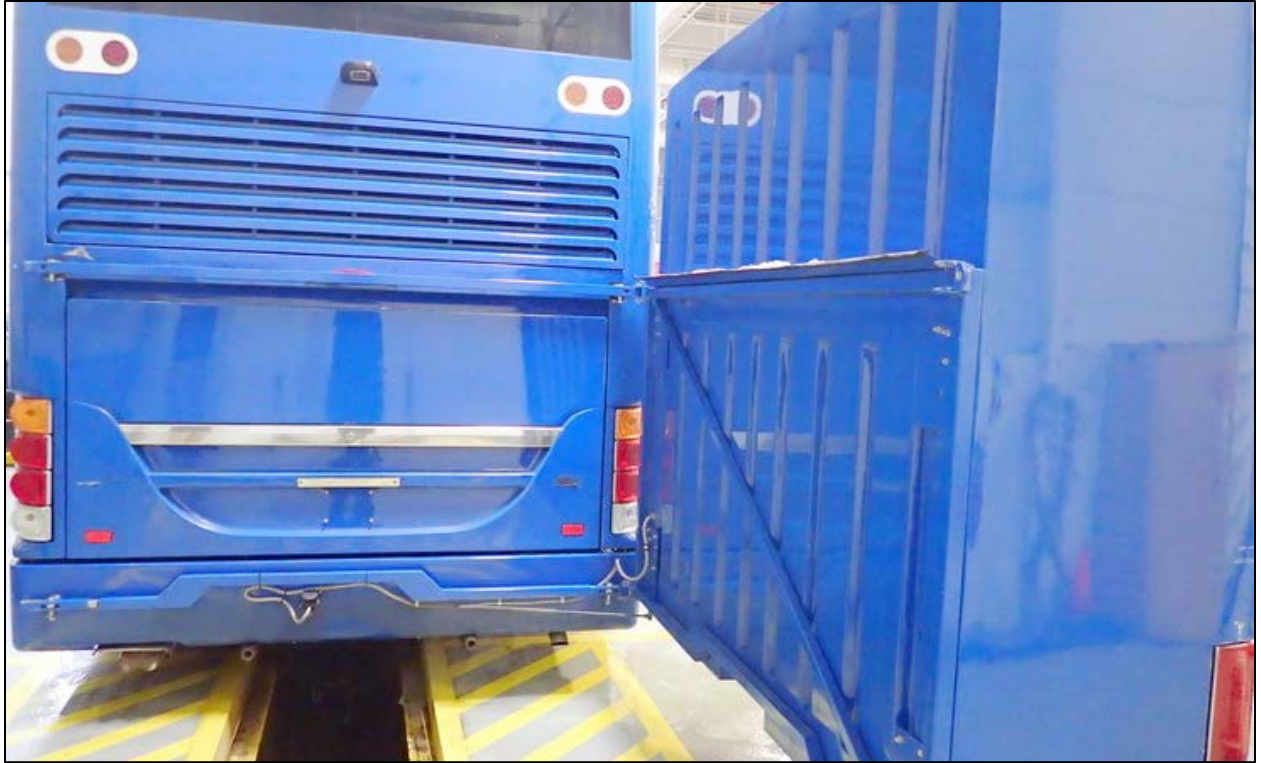
Figure 4 shows how the rear luggage compartment can swing on hinges on the right side of the compartment after a latch on the left side is disconnected.

**Figure 4. Photo. The luggage compartment can swing away from the motorcoach.**

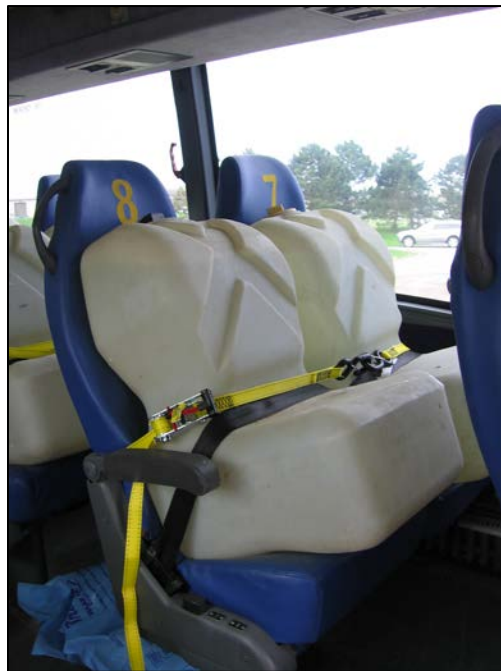
Passenger weight was simulated by water dummies, torso-shaped polymer tanks that can be strapped to seats to simulate passenger weight (Figure 5). A water dummy weighs about 175 lb when completely full. A standard occupant is 150 lb, and the passenger-compartment luggage allocation is 10 lb, for a total weight per occupant of 160 lb. Each water dummy was left approximately one gallon short of full. This headspace permitted little sloshing to affect the dynamics. Luggage weight was simulated by bags of salt, which were placed in the luggage compartment within the vehicle itself or in the rear luggage compartment. In the maximum loading condition, water dummies were put in the aisle in the upper and lower decks, and salt bags were put on the floor of the passenger compartment. Putting all of the additional weight for the maximum loading condition in the luggage compartment would have put too much weight on the rear axles.

**Figure 5. Photo. Water dummies to simulate passenger weight were strapped to the seats in the motorcoach.**

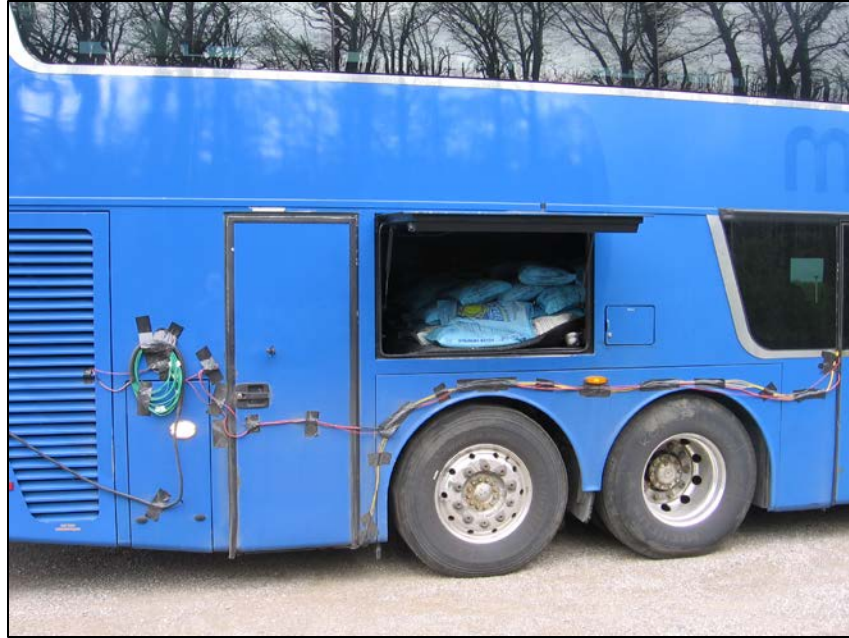
**Figure 6. Photo. Salt bags in the luggage compartment in the vehicle, which is aft of the lower deck seating.**

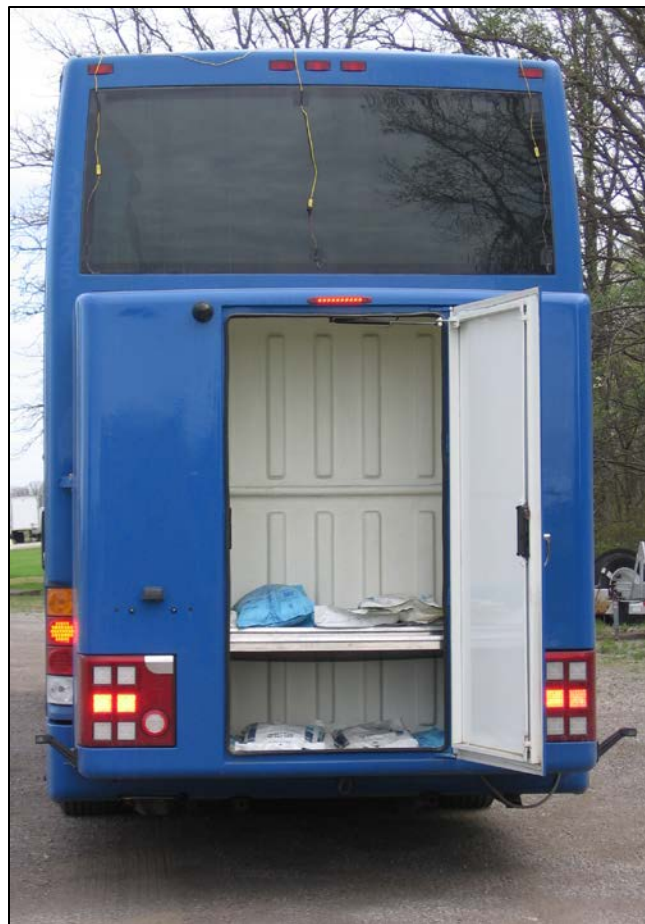
**Figure 7. Photo. Bags of salt were distributed on shelves of the rear luggage compartment.**

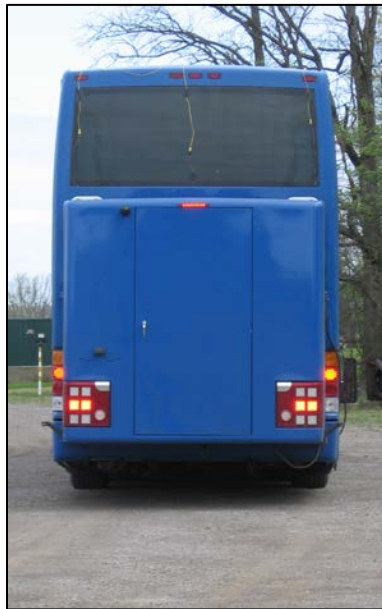
**Figure 9. Photo. The lamps on the vehicle itself and those on the rear luggage compartment were visible from directly behind the vehicle.**

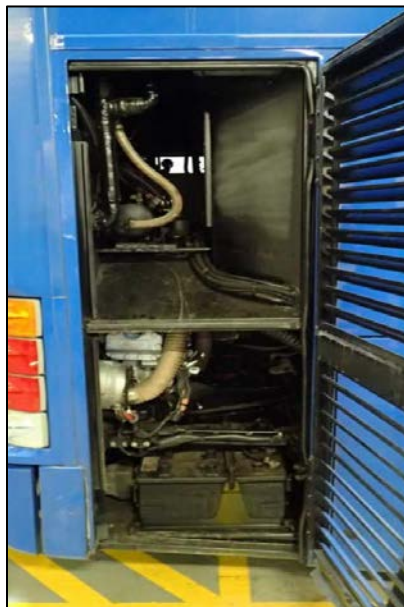
**Firefighter access.** The tested motorcoach had engine compartment access panels on the left and right sides. There was also a rear access panel, which could not be opened when the rear luggage compartment was in place. Although the left-rear access panel would limit capabilities for firefighter access to the engine components, the right-rear access panel, shown in Figure 11, would provide sufficient access to allow firefighters to extinguish an engine compartment fire. Access to the left and right side engine panels would be more difficult if the motorcoach rolled on its side. One side door would be against the ground, the rear door covered by the luggage compartment, and the other side door accessible only by ladder.

**Figure 11. Photo.** The engine compartment access door on the right side of the motorcoach would provide adequate capability for a suppression crew to extinguish a fire in the engine compartment.

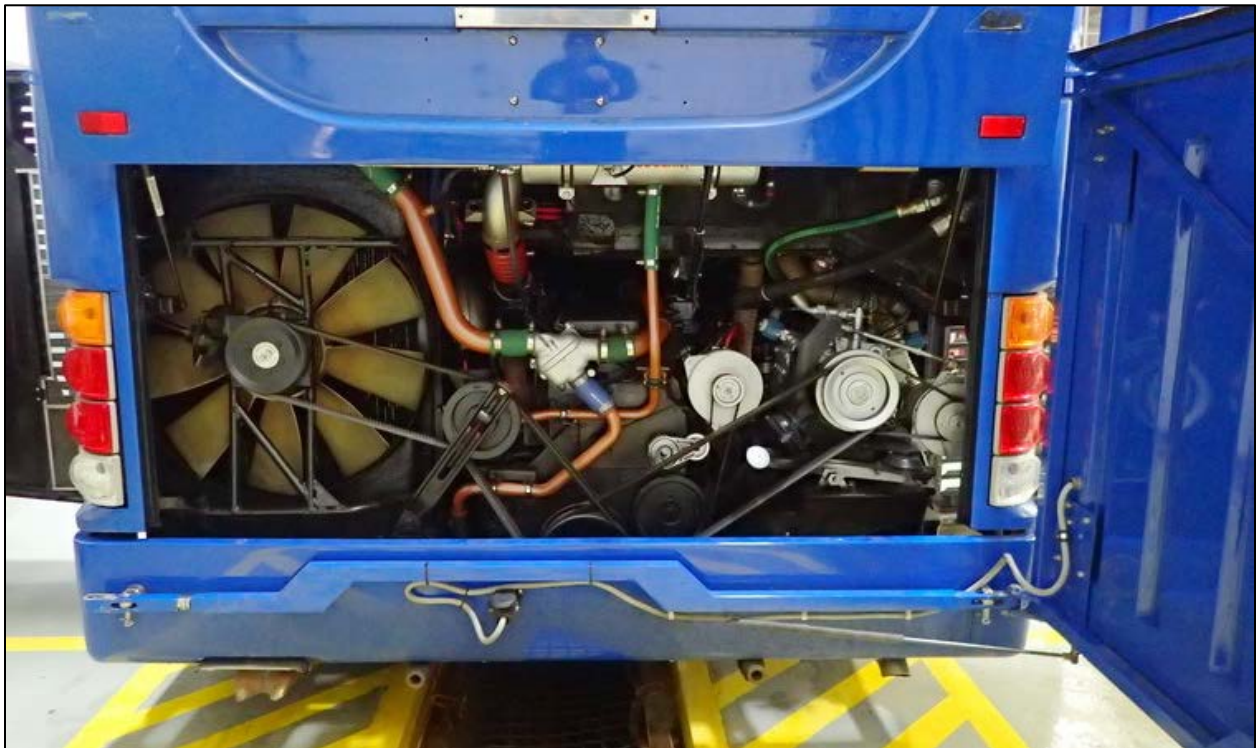
The rear luggage compartment used in this study can swing away from the vehicle on a pair of hinges. Figure 12 shows the luggage compartment swung away and the main engine compartment door open. During fire suppression or rescue efforts, if the rear storage compartment had to be removed, firefighters would have several options: (1) remove the pins—a Halligan bar could push or pull the four pins; (2) use cutting tools, such as a K12 fire rescue saw or hydraulic cutters to cut sections of the frame; or (3) use hydraulic spreaders to pop the frame off the compartment or motorcoach. When conducting their inspections during this study, inspectors removed the pins using a hammer and chisel (see Figure 13) and swung the rear luggage compartment opened in approximately 30 seconds. They estimated that a K12 fire rescue saw could cut through the hinges in a comparable time.

**Figure 12. Photo.** The engine compartment was accessible after the luggage compartment (visible at the right) was swung out of the way and a door was lifted.

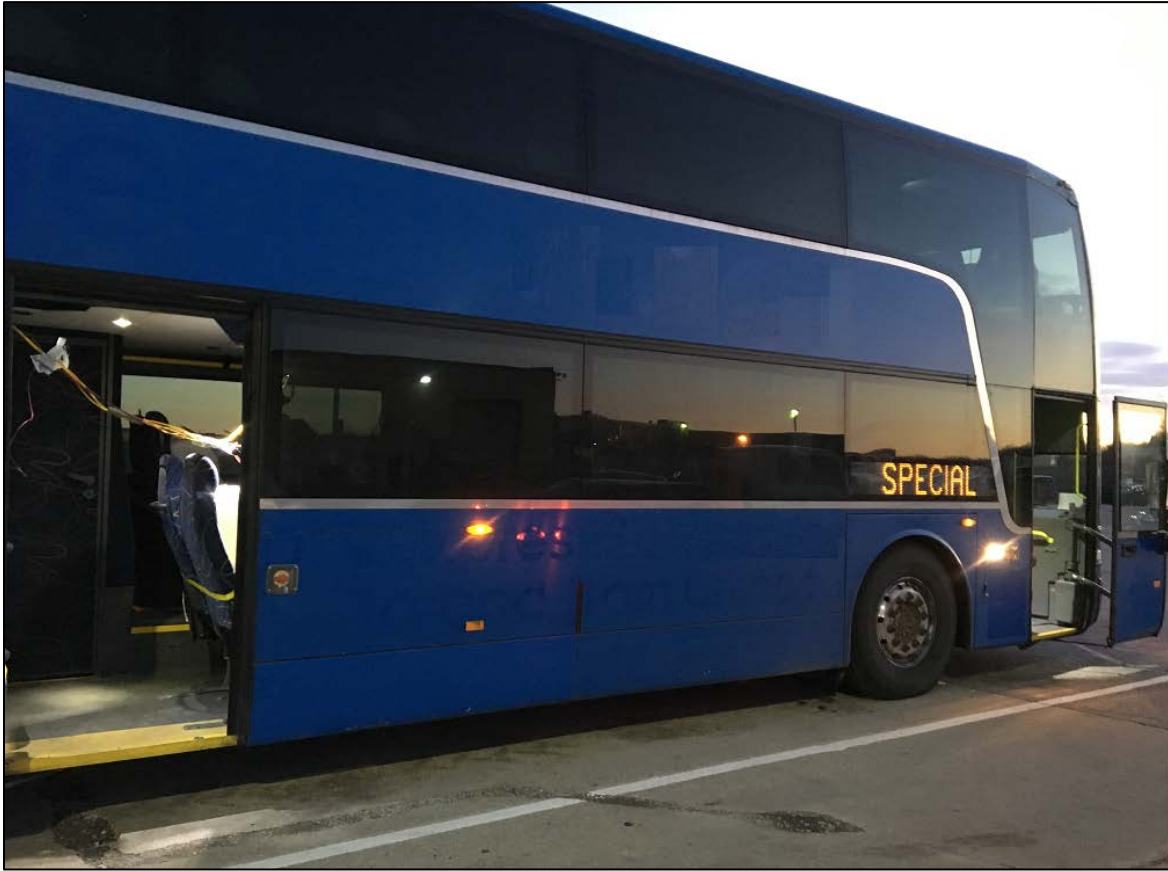
**Figure 17. Photo. The motorcoach had doors at the front and rear. It had two stairs, one by each door.**

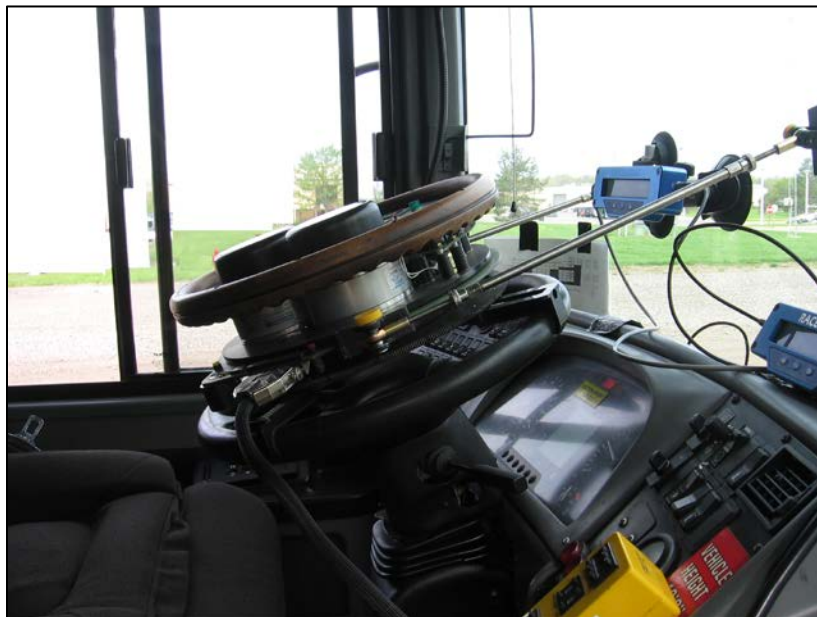
**Figure 18. Photo. The steering machine provided repeatable inputs for the high-speed maneuvers.**

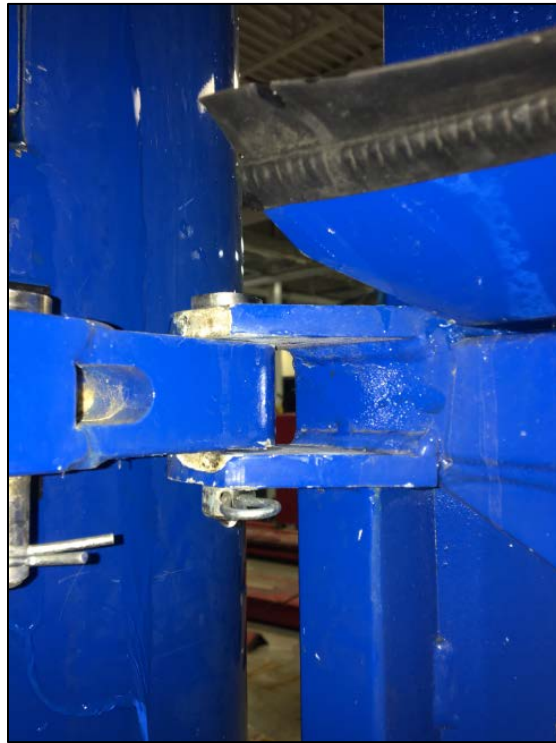
A close-up of the hinge that was instrumented is shown in Figure 29. The rear of the motorcoach is in the left of the picture and the forward surface of the luggage compartment is to the right. Figure 30 is a finite-element model of the hinge, from approximately the same vantage point.

**Figure 29. Photo. This hinge was instrumented for the structural integrity assessment.**
